**NATIONAL TRANSPORTATION SAFETY BOARD**  
**Office of Marine Safety**  
**Washington, D.C. 20594**

**Survival Factors Group Chairman's**  
**Factual Report**

**U.S. Navy/ USS *Greeneville* (SSN772)**

Ehime Prefecture/ *Ehime Maru*

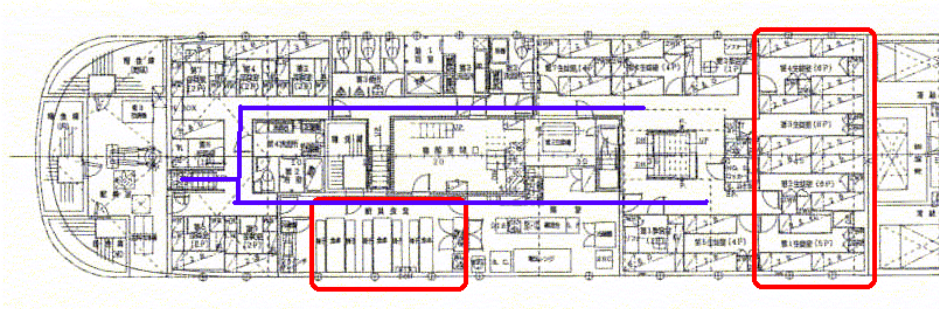
Figure 1. 2<sup>nd</sup> deck showing Berthing and Mess deck Areas

The majority of the survivors describe being on the 2<sup>nd</sup> deck at the time of the collision, either in their cabins or on the crews' mess deck. These general areas are outlined with rectangles on figure 1. Their primary egress routes were aft along the passageways to the ladder going up to the fantail area. The straight lines on figure 1 show this.

Those survivors who exited cabins on the 2<sup>nd</sup> deck near the stairwell descending to the 3<sup>rd</sup> deck describe the stairwell as being full of water and fuel as soon as they stepped out of their cabins.

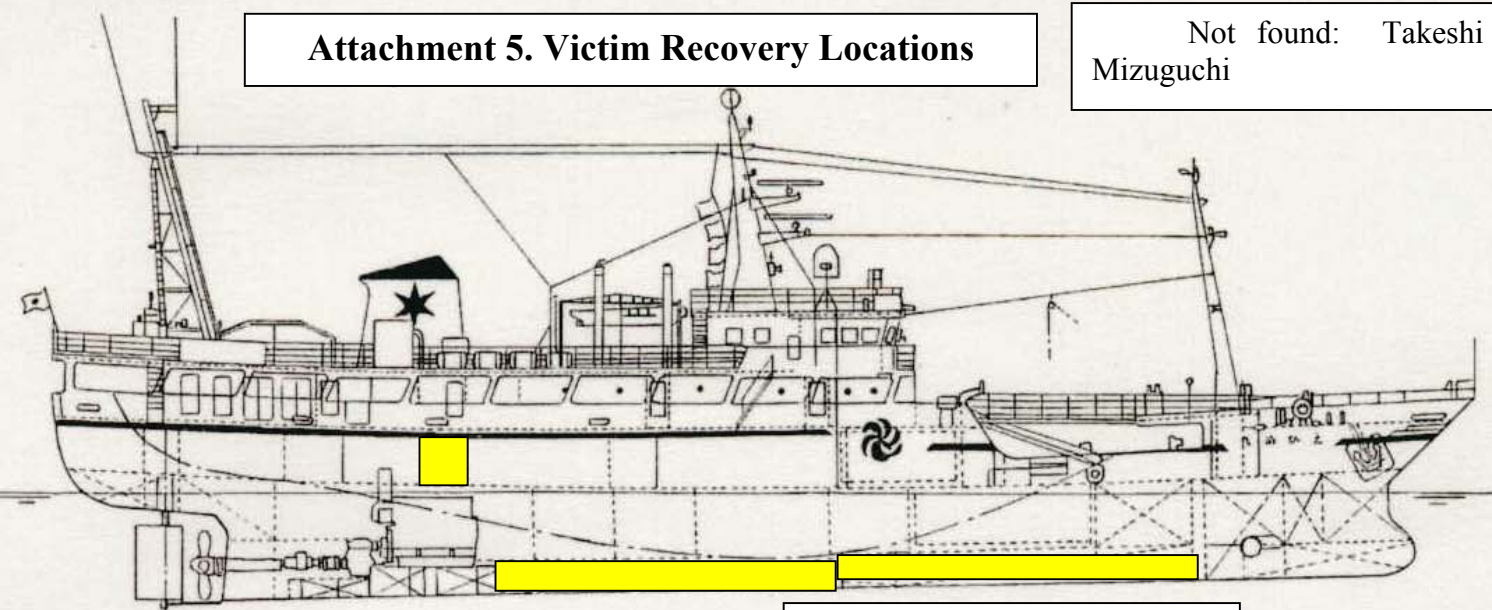
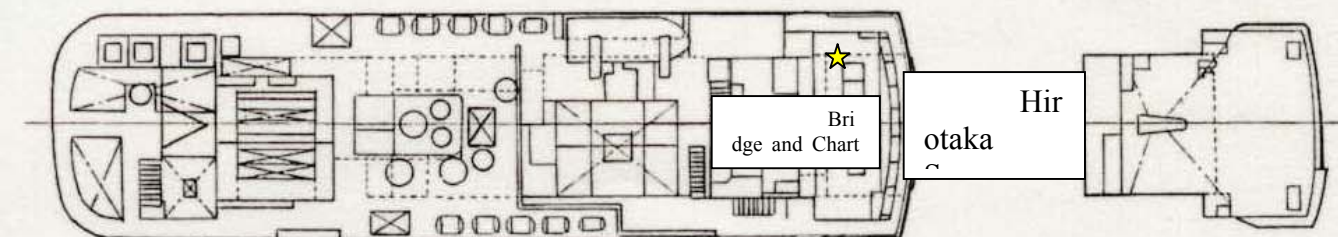
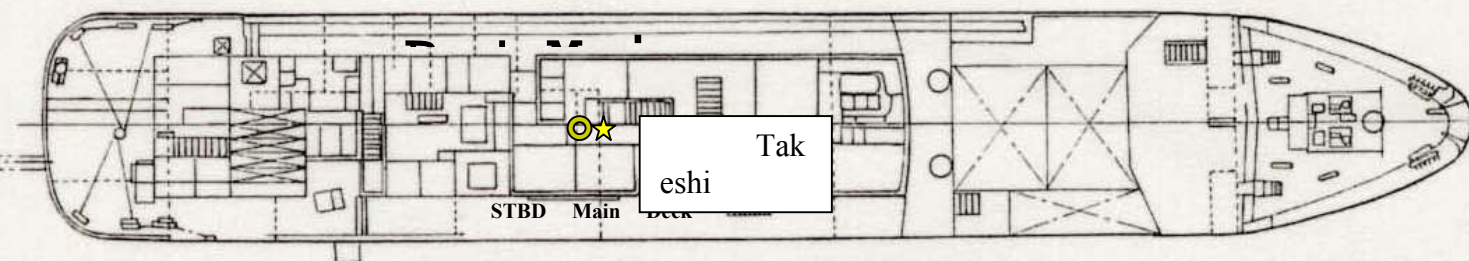
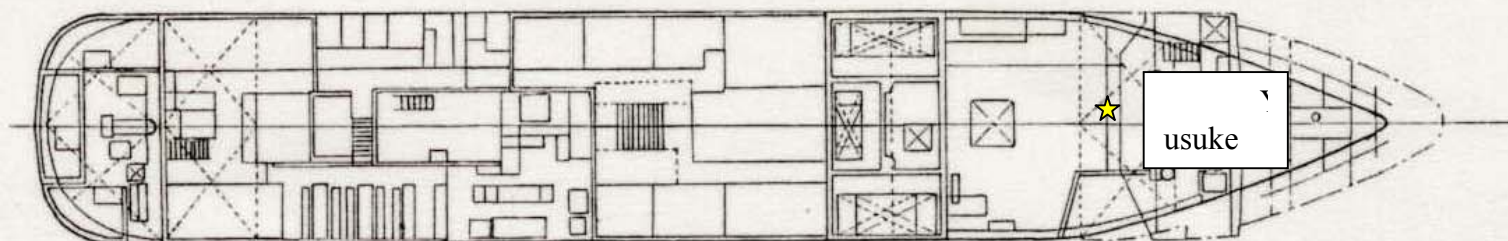
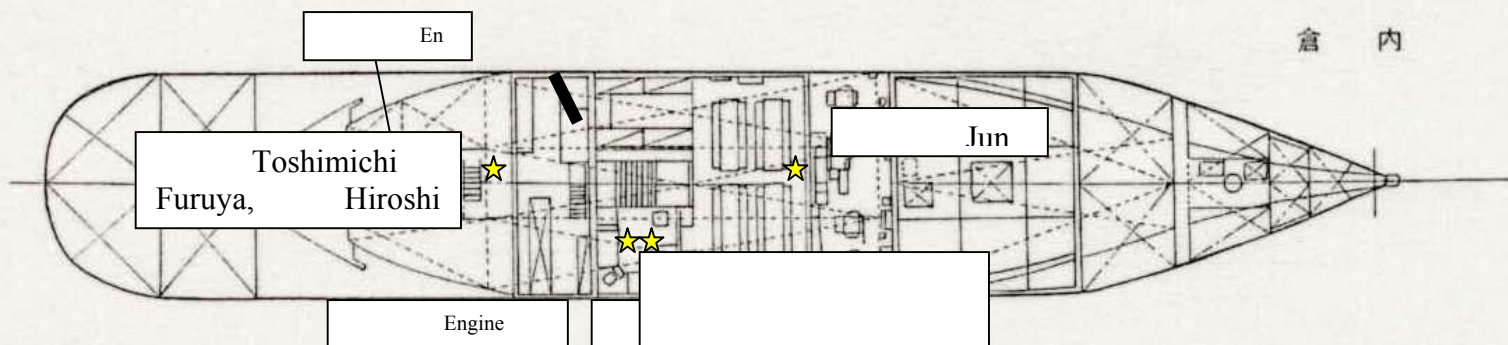
## Attachment 5. Victim Recovery Locations

- Chief and First Engineer in the engineroom.
- Chief Radio Officer inside the bridge.
- Two students and a teacher in the student lounge and computer room.
- A student in the forward section of the 2<sup>nd</sup> deck.
- A teacher in the center passageway on the main deck. (The Navy Diagram lists this person as the missing student – it is assumed this is the position of the recovered teacher that is not otherwise identified on the diagram)
